Restoring a Doyle Lane Mural

By Kevin Durkin | May 29, 2015

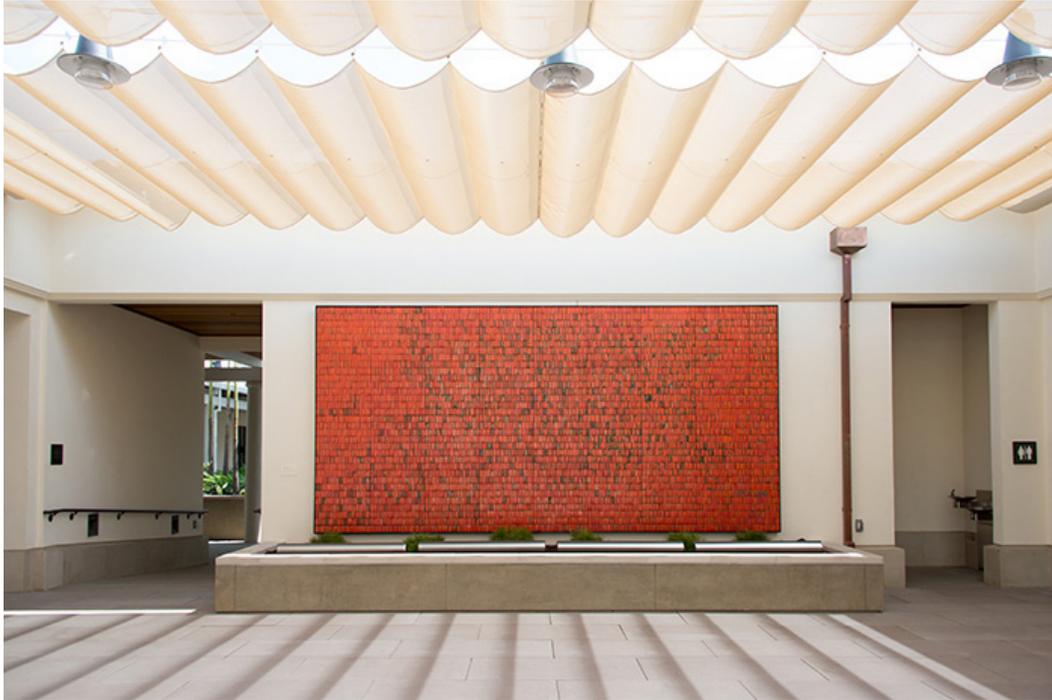
Doyle Lane, *Mutual Savings and Loan Mural*, 1964, clay, 17 × 8 ft., as installed in the courtyard of the June and Merle Banta Education Center, part of the Steven S. Koblak Education and Visitor Center. The Huntington Library, Art Collections, and Botanical Gardens.

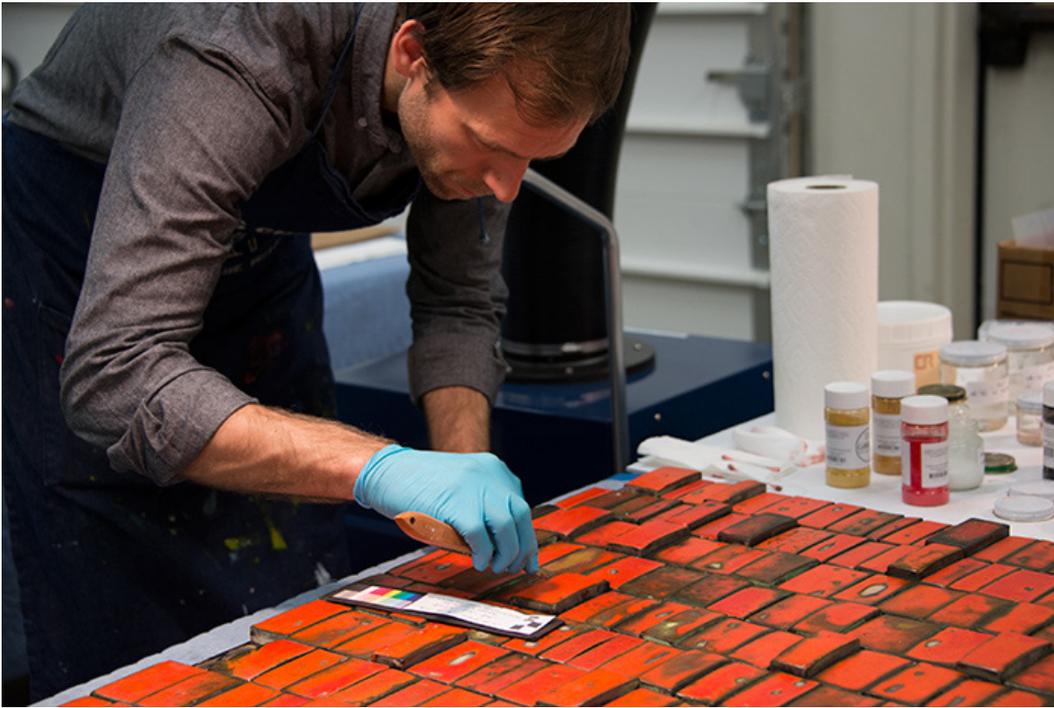
Sculptor and freelance conservator Morgan MacLean used an artist knife to apply treatment to damaged tiles.

A: Using an artist knife, I applied to each damaged section a thin coat of a treatment comprising acetone, Paraloid B-72 (a clear acrylic resin), marble powder, and dry pigment. Some tiles had as little as a 1/8-inch loss of glaze, but sometimes a tile was cracked in half and about two inches of glaze was lost. When a lot of glaze was lost, I had to build up layers of treatment slowly over several days, creating a surface that resembled the rest of the tile. That was a fun but tricky process because of the variation of colors. I would first apply a treatment with a light cadmium red pigment, and then the next day, I would apply another treatment with a little darker cadmium red so that you could see the light coming through the dark, producing a natural glaze appearance. After the treatment dried for a while, I would go over the tile with a dry brush to create little dimples in it so it looked like dried natural glaze.

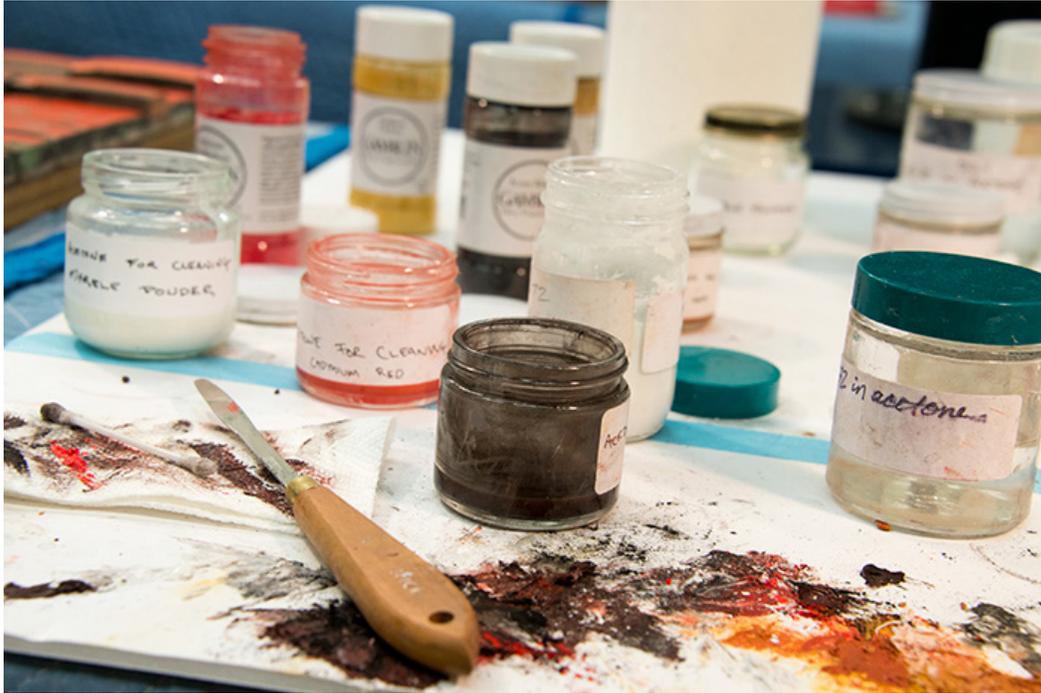
To repair tiles, MacLean prepared a treatment comprising acetone, Paraloid B-72 (a clear acrylic resin), marble powder, and dry pigment.

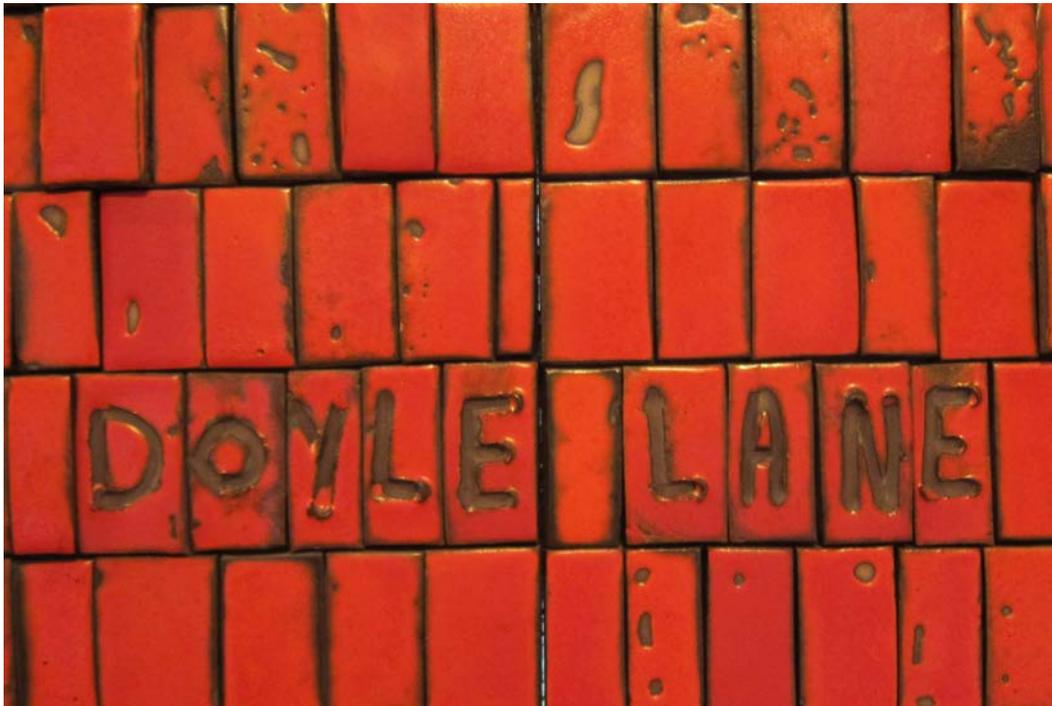
Doyle Lane's signature on *Mutual Savings and Loan Mural*. The Huntington Library, Art Collections, and Botanical Gardens.
